NEVADA DIVISION
OF WATER RESOURCES

EAPs in Nevada 101

**Danny Larson, Water Resource Specialist
NDWR, Dam Safety Program**

**Keith Johnson, P.E., Staff Engineer II
NDWR, Dam Safety Program**

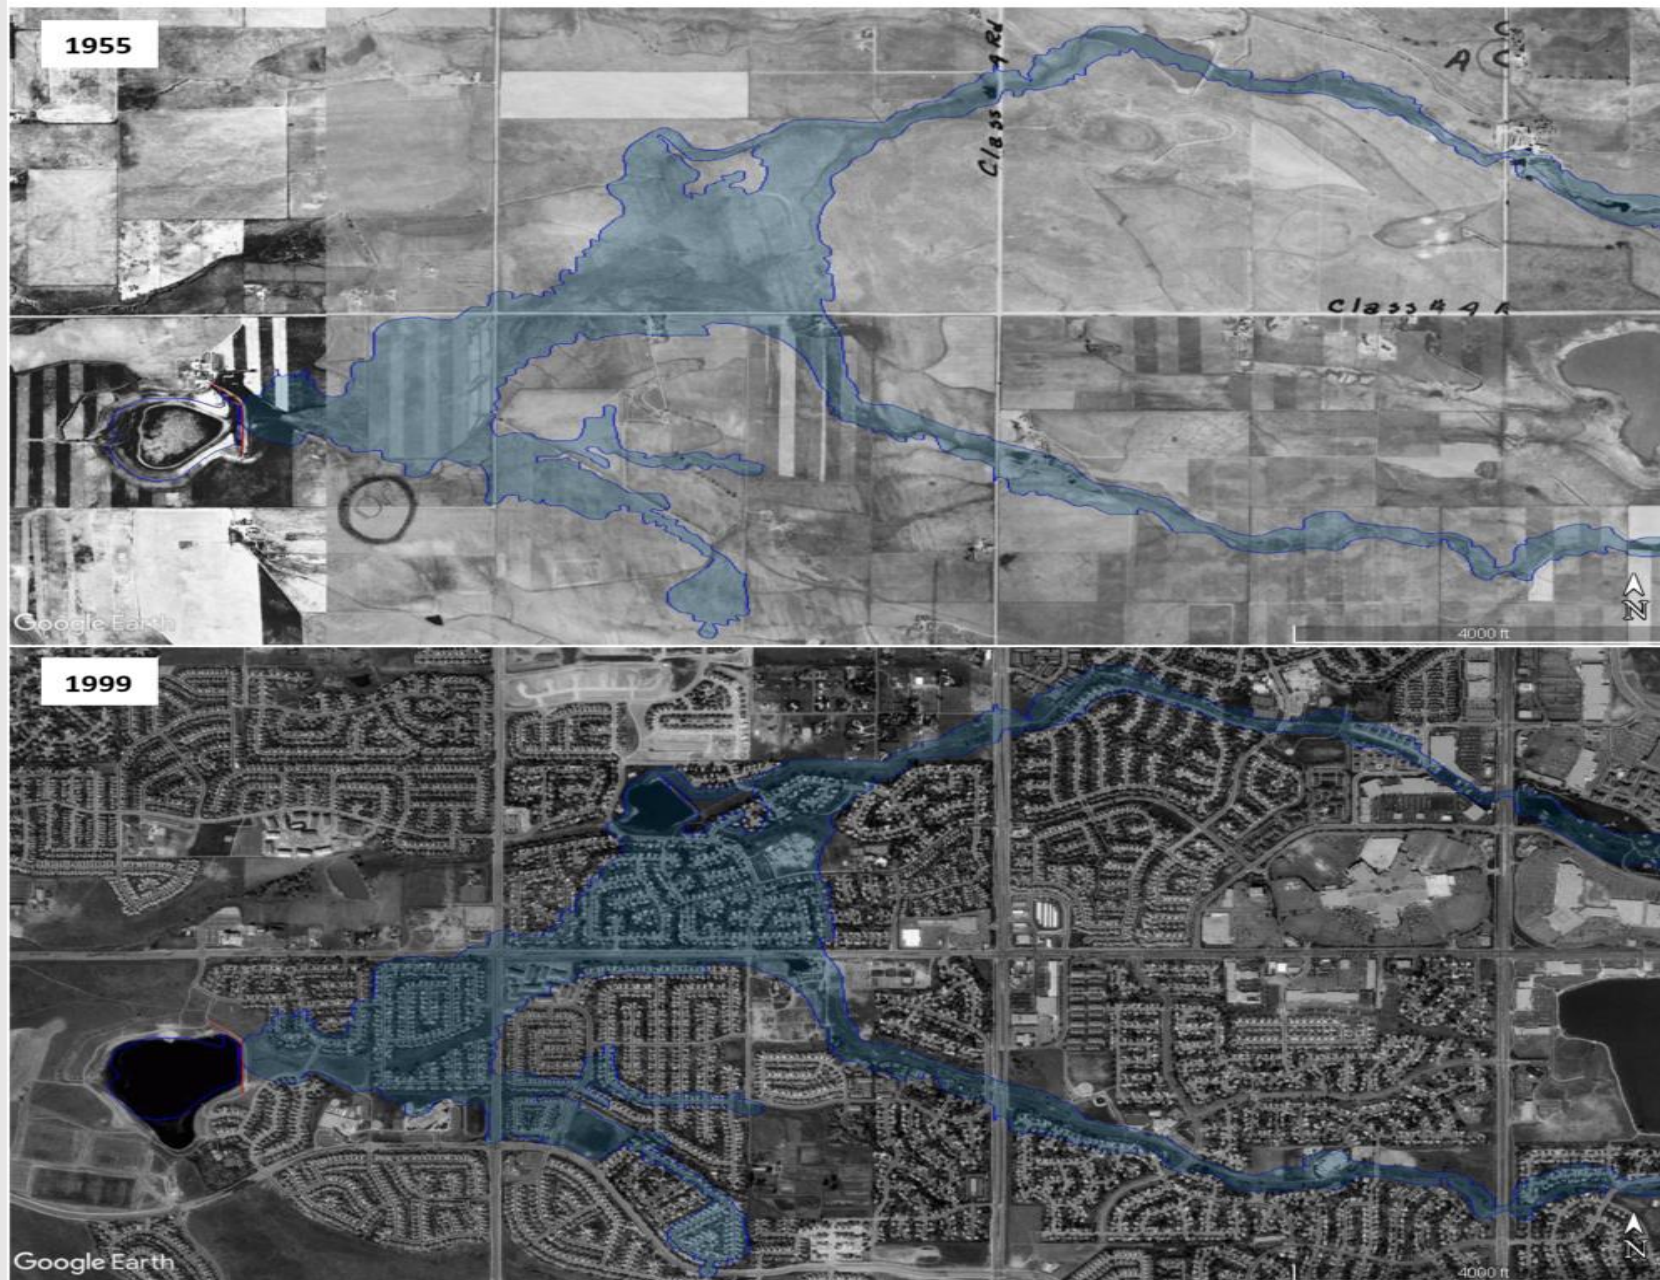
Aerial imagery comparison (1955 vs. 1999) showing infrastructure development within the current dam breach inundation limits downstream of a High hazard dam in southwest Denver, Colorado.

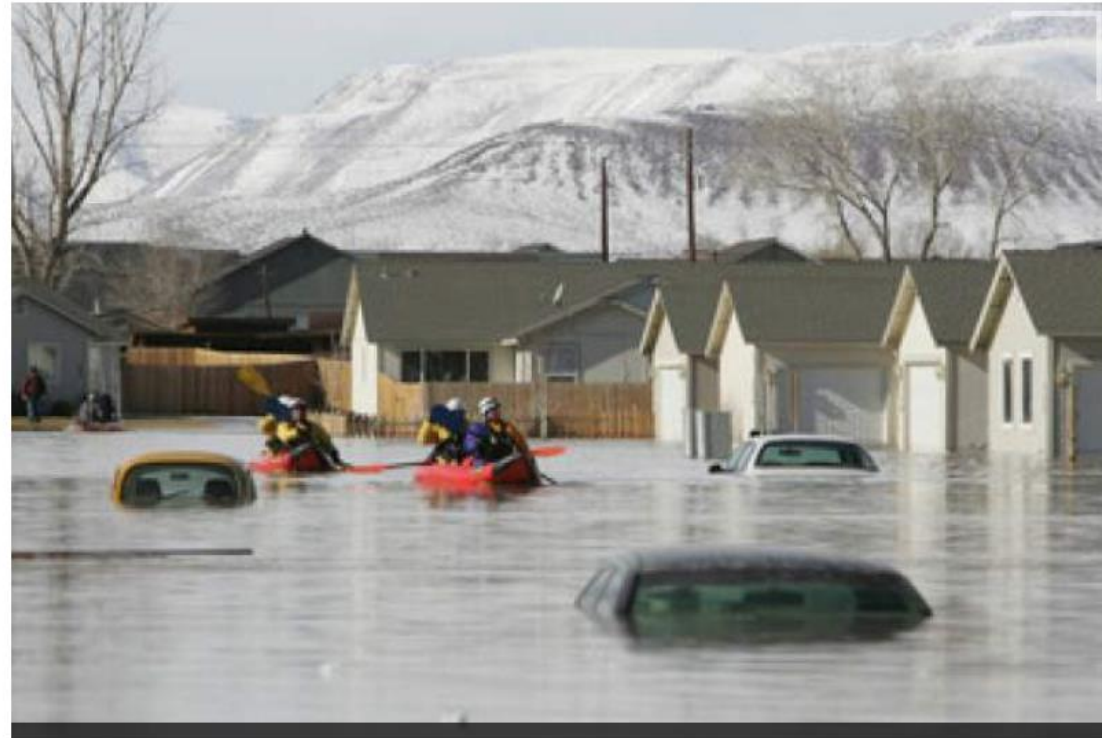
Truckee Canal Failure (Nevada, 2008)

Rodent burrows blamed in canal failure

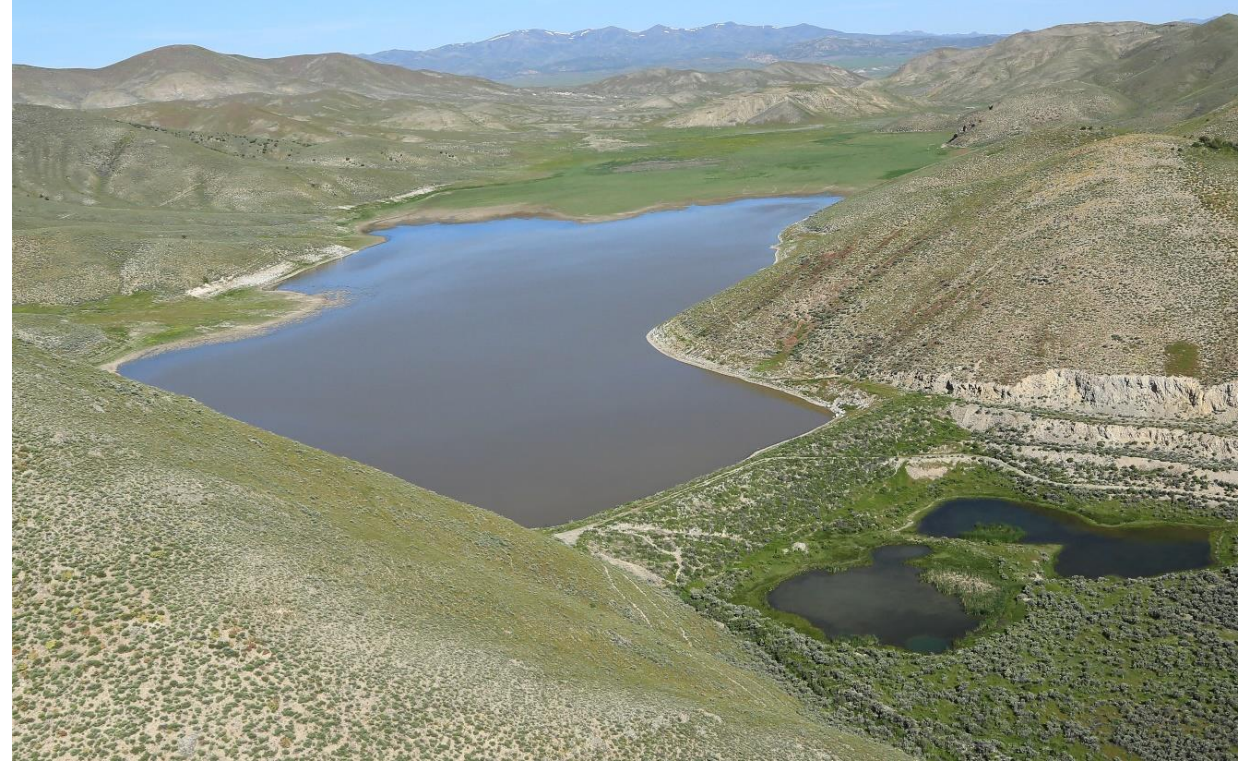
Twenty-One Mile Dam Failure (Nevada, 2017)

- Hazard: Low
- Length: 600 ft
- Height: 47 ft
- Spill Width: 40 ft
- Structural Height: 47 ft
- Number of Outlets: 1
- Max Discharge: 100 CFS
- Normal Storage: 5500 AF
- Surface Area: 100 Acres
- Drainage Area: ~680 sq. mi.
- Construction Year: ~1915

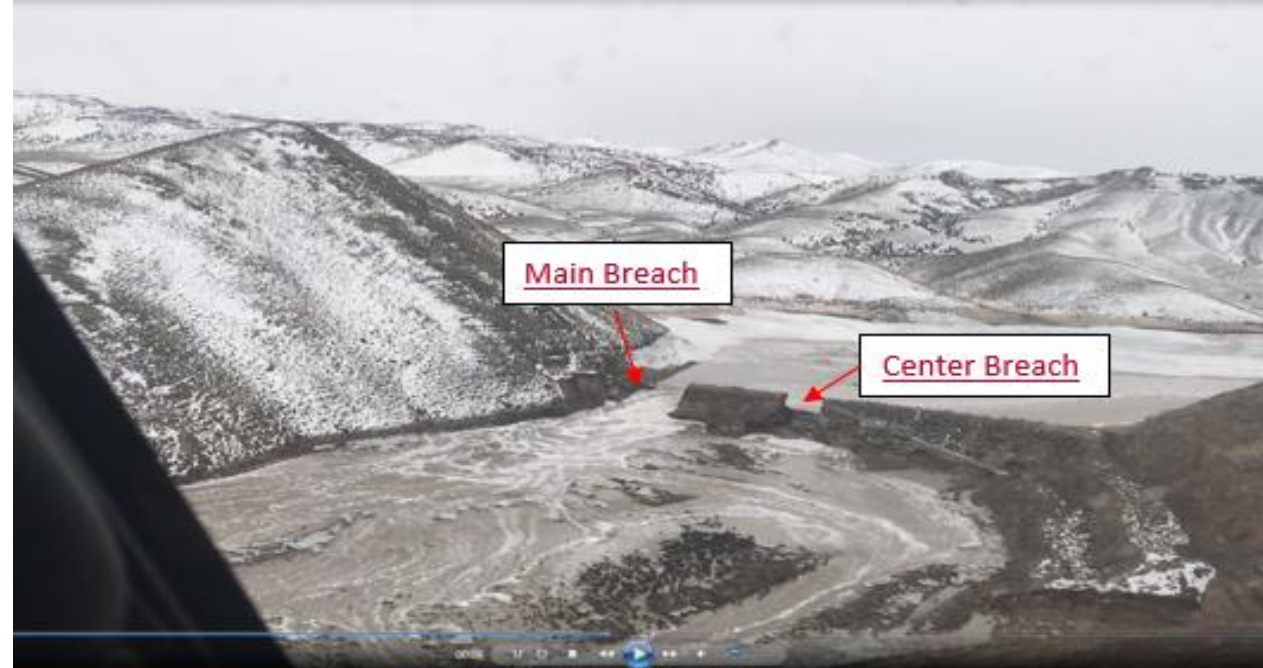
- Center Breach area was about 50 feet wide and 40 feet deep.
- The Main Breach is located near the right abutment was about 120 feet wide and greater than 50 feet in depth.
- Over 1.5 inches of rain on top of snow that was melting. (Remember ~680 square mile watershed).

View from the news helicopter the day after the breach (2/9/17)

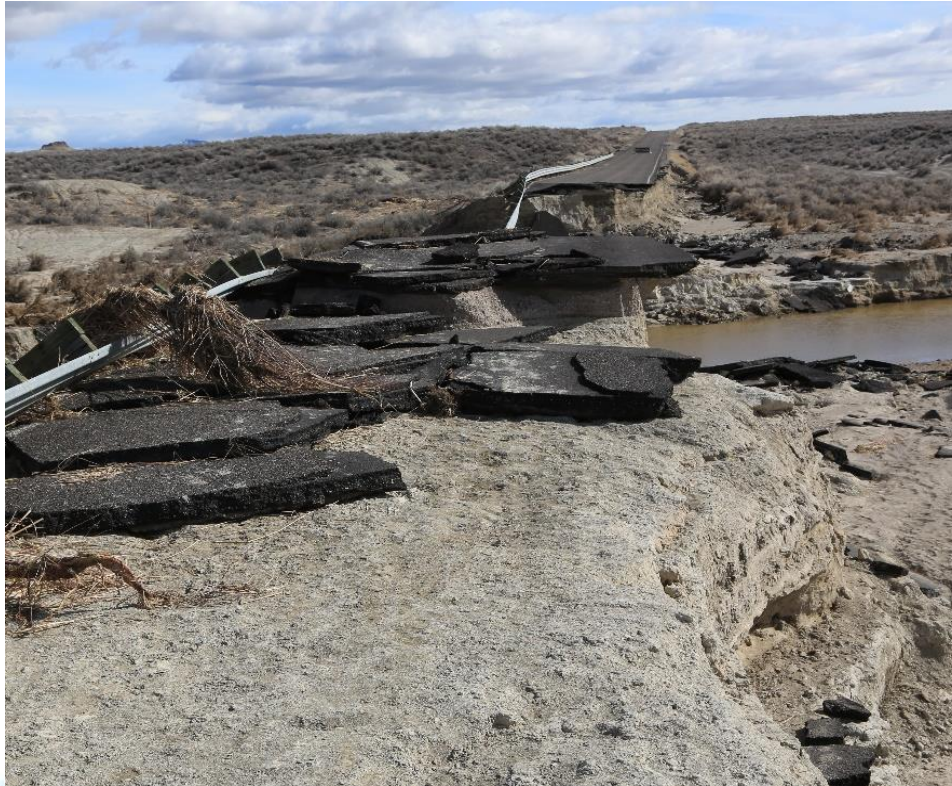
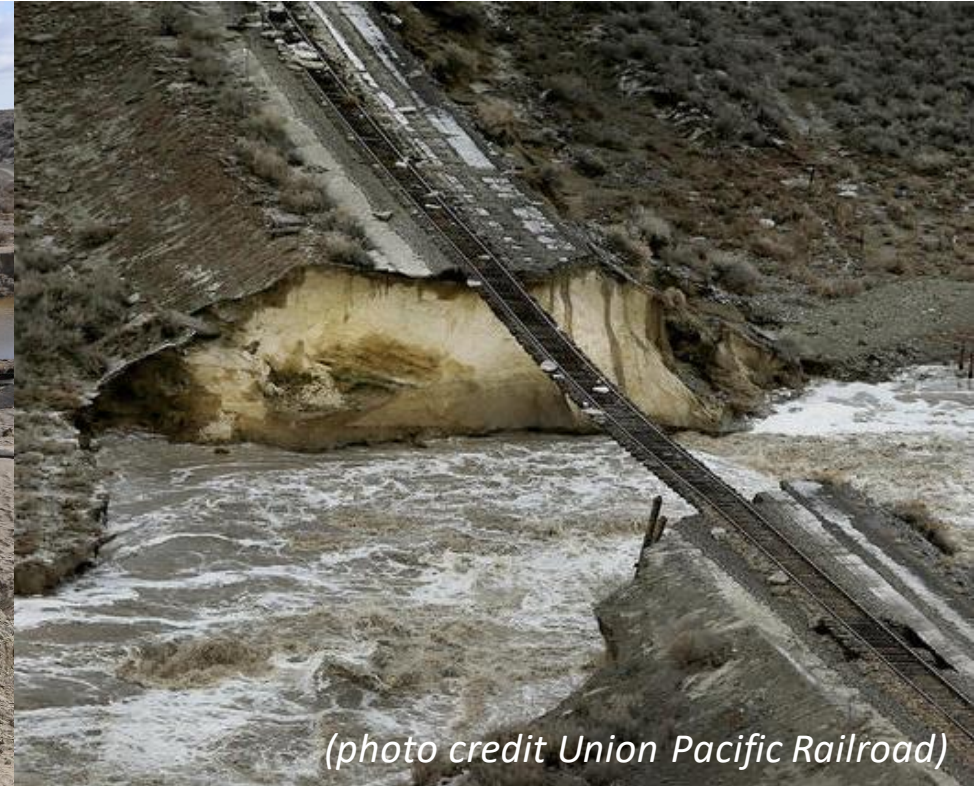
HWY 223 below Dake Reservoir

UPRR Railroad downstream of HWY 223

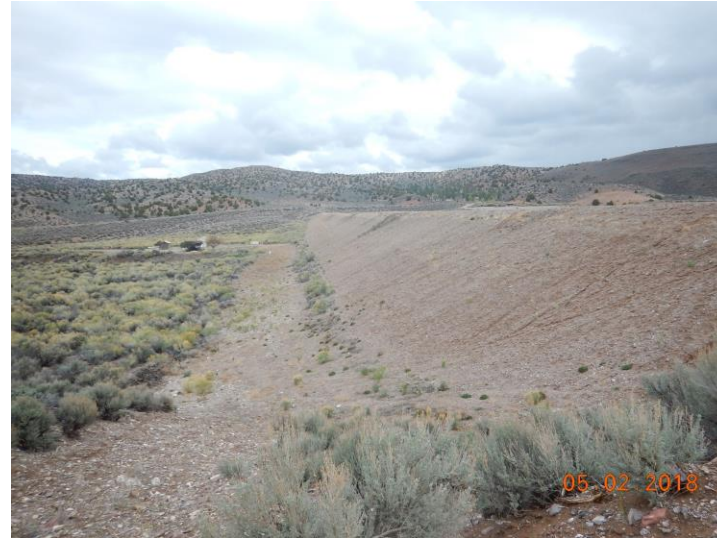
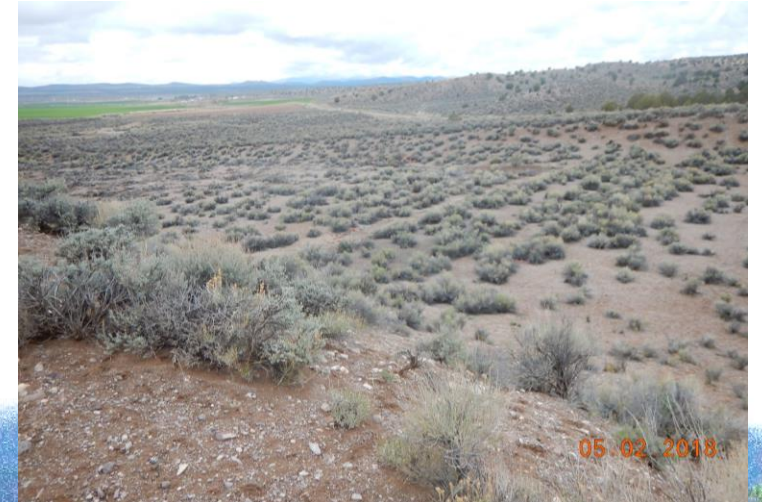
- Hazard: High
- Length: 1,500 ft
- Height: 60 ft
- Spill Width: 50 ft
- Number of Outlets: 1
- Max Discharge: 12,000 CFS
- Normal Storage: 1,500 AF
- Surface Area: 64 Acres
- Watershed Size: ~360 sq. mi.
- Construction Year: ~1970

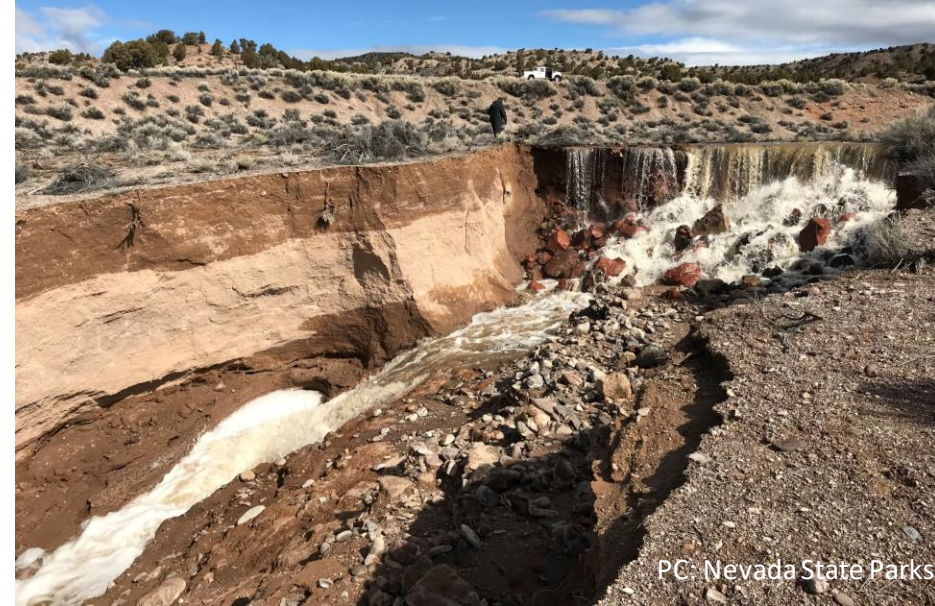
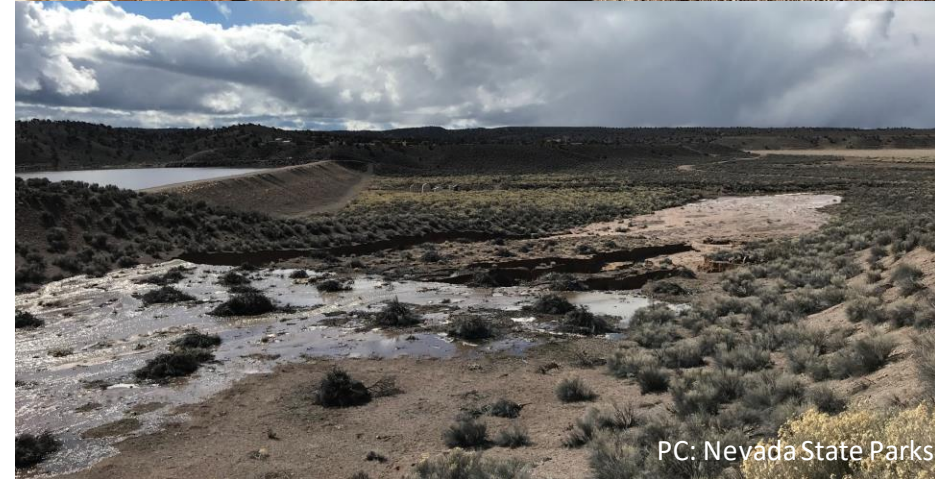
Echo Canyon Dam

- On March 6, 2019 excess snow melt above the reservoir caused the auxiliary spillway to run for the first time.
- Approximately 6" of water was flowing over the spillway and caused the spillway soil to erode.
- The water flowed over the spillway till approximately March 14th.
- The erosion stopped at one of the three rock cutoff walls installed in the spillway.
- Currently assessing repairs and associated cost.

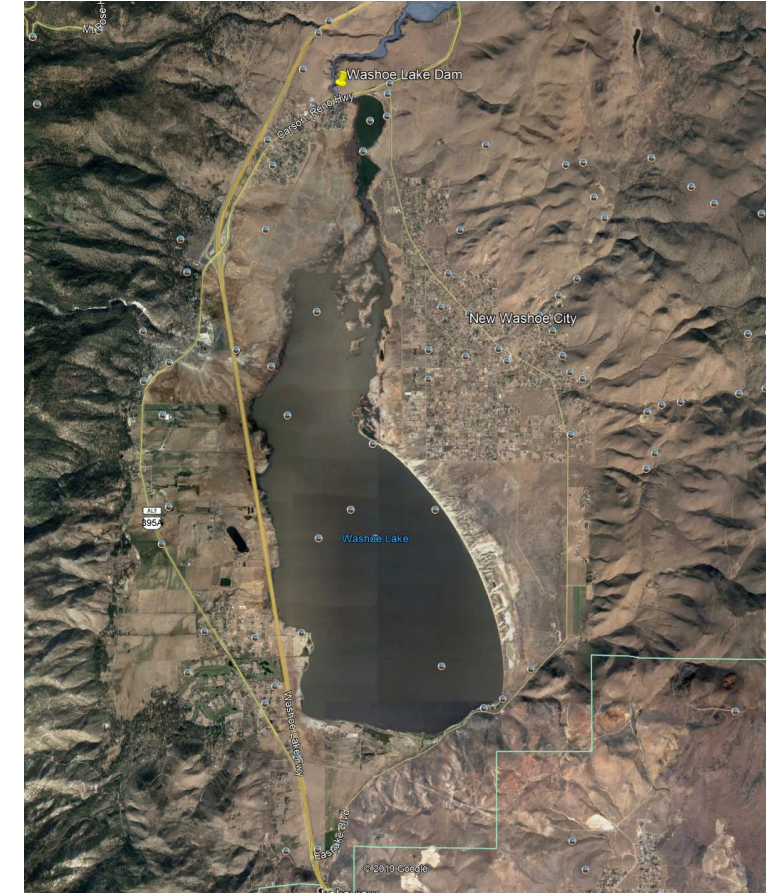
- Hazard: High
- Length: 30 ft
- Height: 12 ft
- Spill Width: 24 ft
- Number of Outlets: 2
- Max Discharge: 200 CFS
- Normal Storage: 300 AF
- Surface Area: 45 Acres
- Watershed Size: ~80 sq. mi.
- Construction Year: ~1860
- Constructed out of Granite Blocks

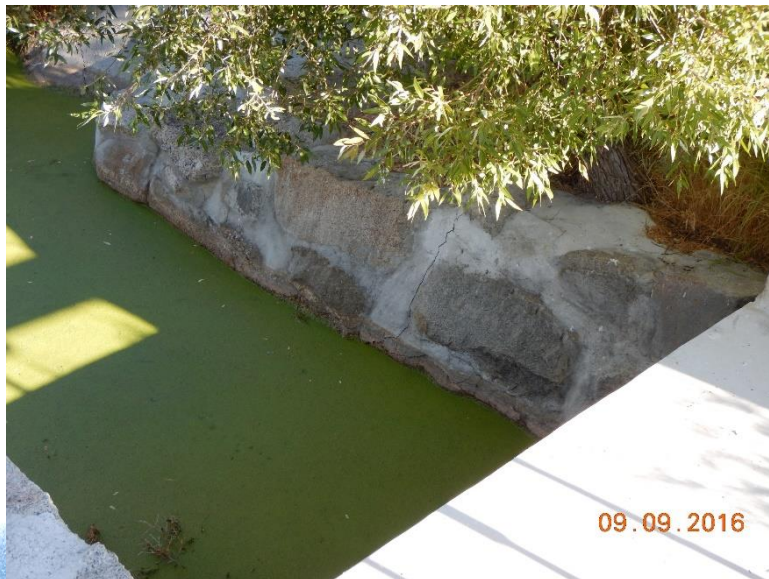
Right Downstream Toe

- Vegetation was extremely thick on upstream and downstream side of the embankment.
- Large Russian olive tree located at toe of downstream embankment.

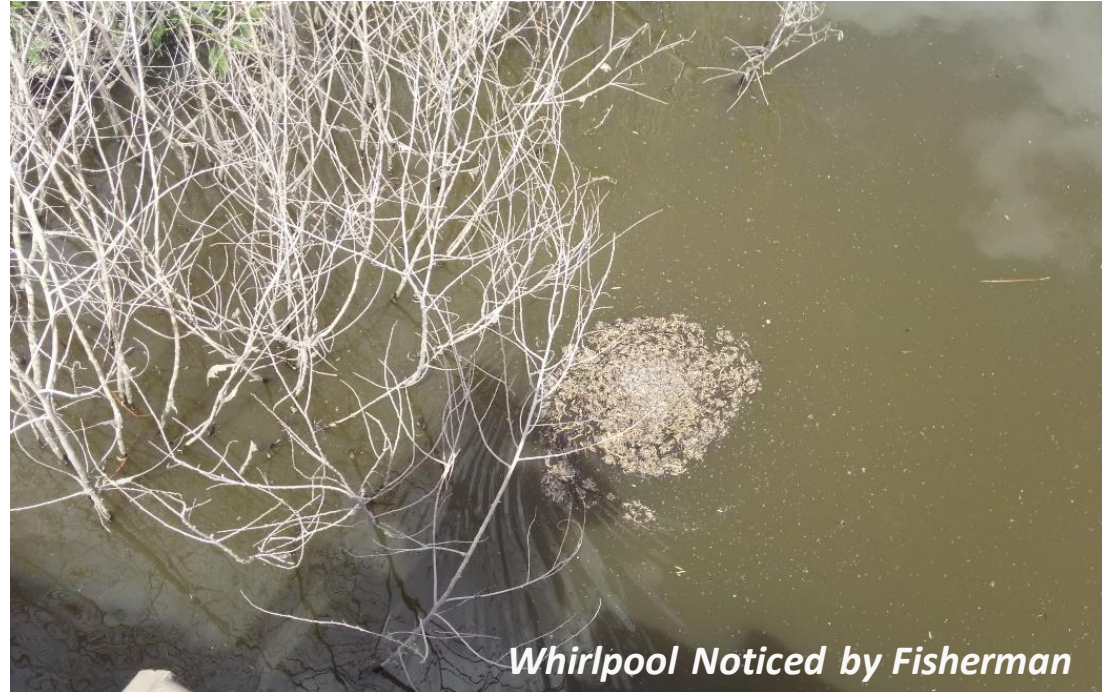
Whirlpool Noticed by Fisherman

- Fisherman posted photo on Facebook the morning of June 18, 2018.
- At noon, our office received a phone call that water was flowing around Washoe Lake Dam.
